# UNDERWATER BRIDGE INSPECTION REPORT

STRUCTURE NO. 36511

BATTLE RIVER

DISTRICT 1 - KOOCHICHING COUNTY

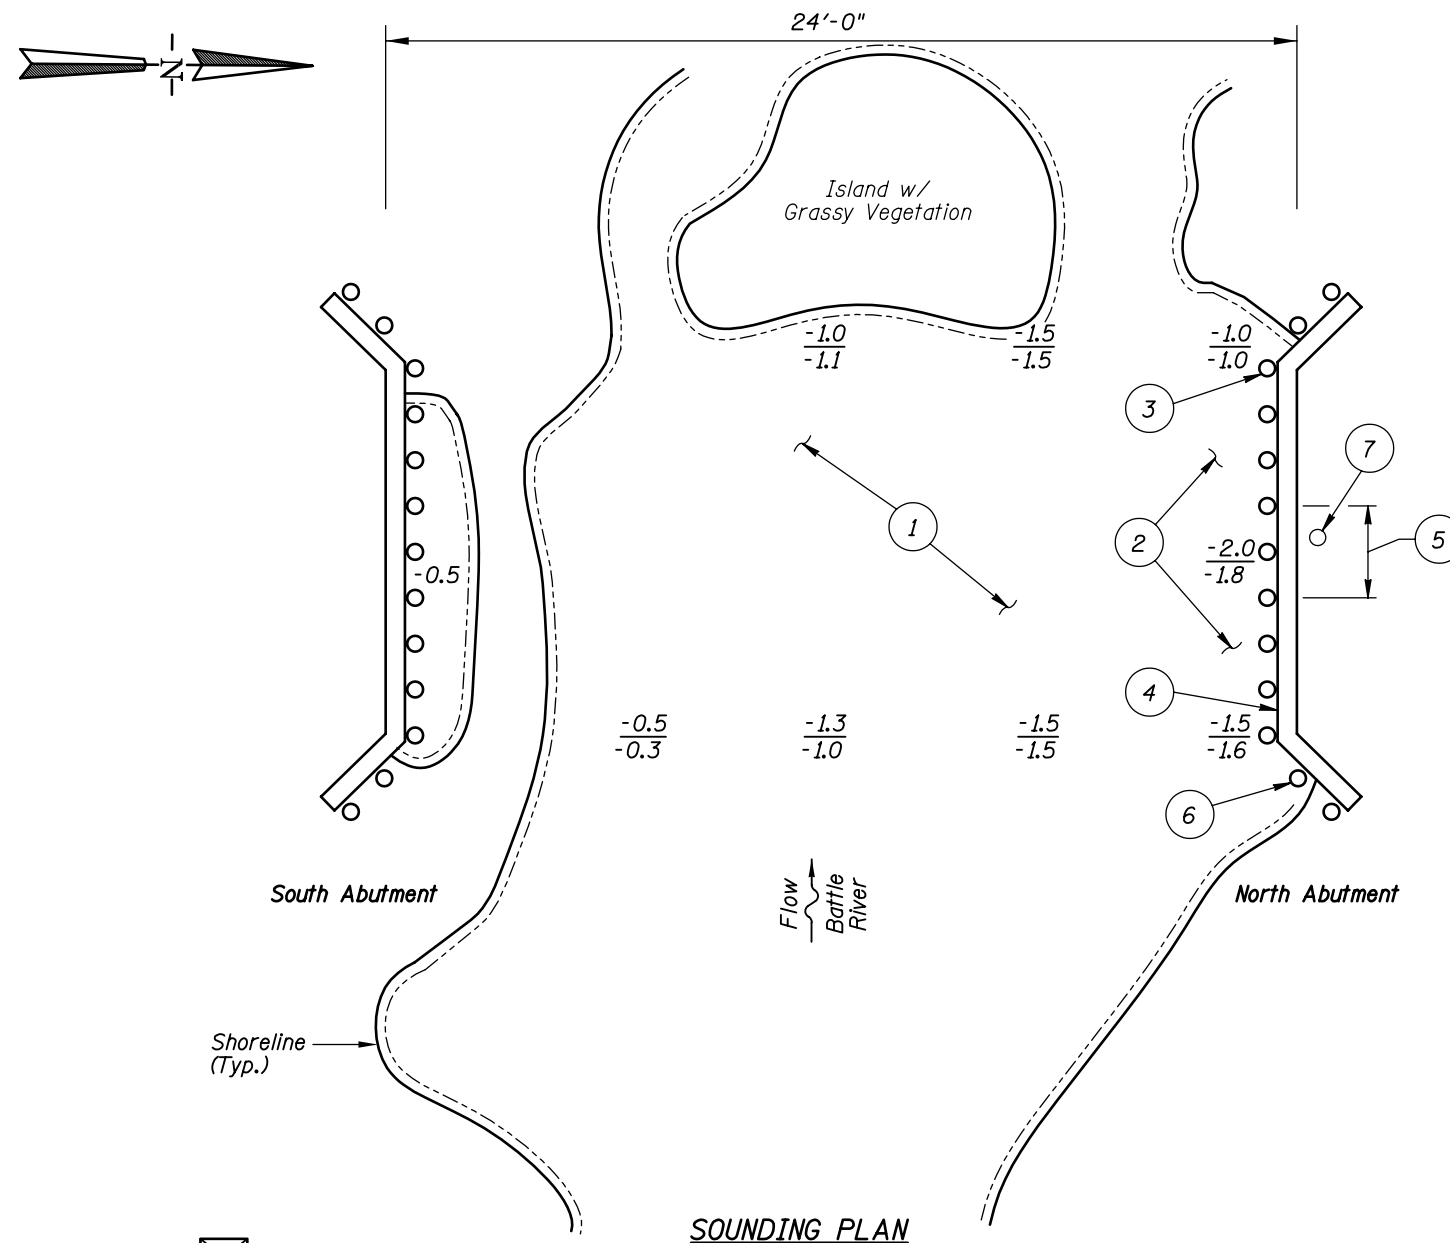
**INSPECTION AND SOUNDING PLAN**

- 1 The channel material consisted of silty clay and sand with up to 1.5 feet of probe rod penetration.
- 2 The channel bottom material at the North Abutment consisted of soft silt over firm clay and gravel.
- 3 Split in pile, at the top 3 feet of the pile, 1/2 inch wide with 2 inches of penetration.
- 4 Wood splintered off breastwall plank at the waterline, 2 inches wide by 3 feet long, with 6 inches of penetration. There appeared to be some gravel from behind the breastwall escaping.
- 5 The bottom of the wall planking was observed 2 feet below the waterline with undermining and 6 inches of probe rod penetration into the backfill.
- 6 The timber pile exhibited loss of section and was decayed at the waterline. Overall, half of the pile was separated but it was still plumb and stable.
- 7 A 5 inch diameter hole with underlying cavity in the pavement behind the North Abutment.

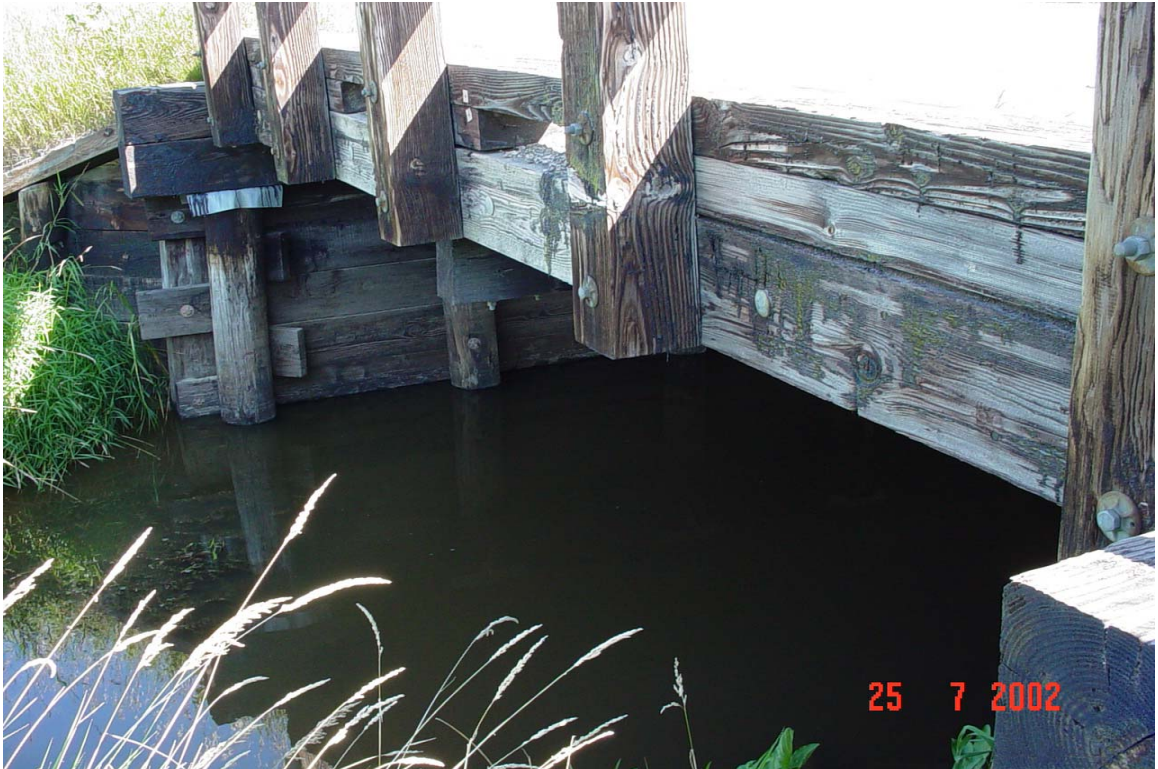
Photograph 1. Overall View of the Structure, Looking Northeast.

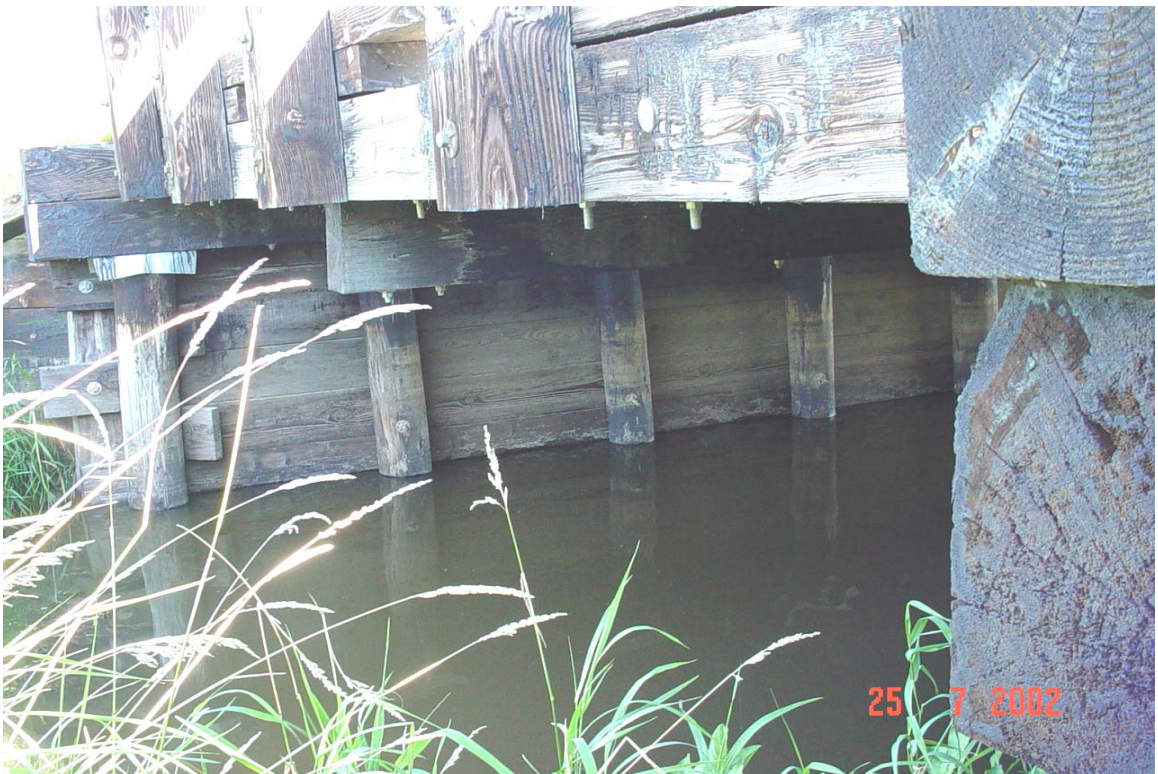
Photograph 2. View of the North Abutment, Looking Northeast.

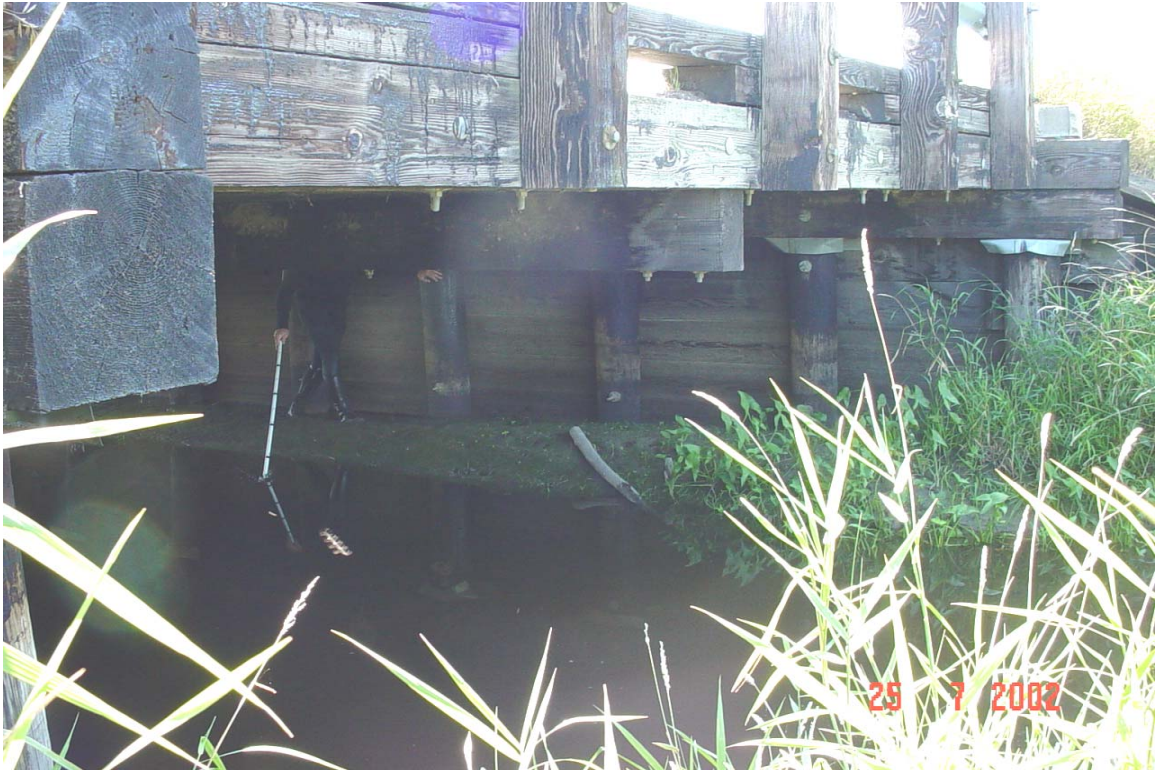
Photograph 3. View of the South Abutment, Looking Southeast.

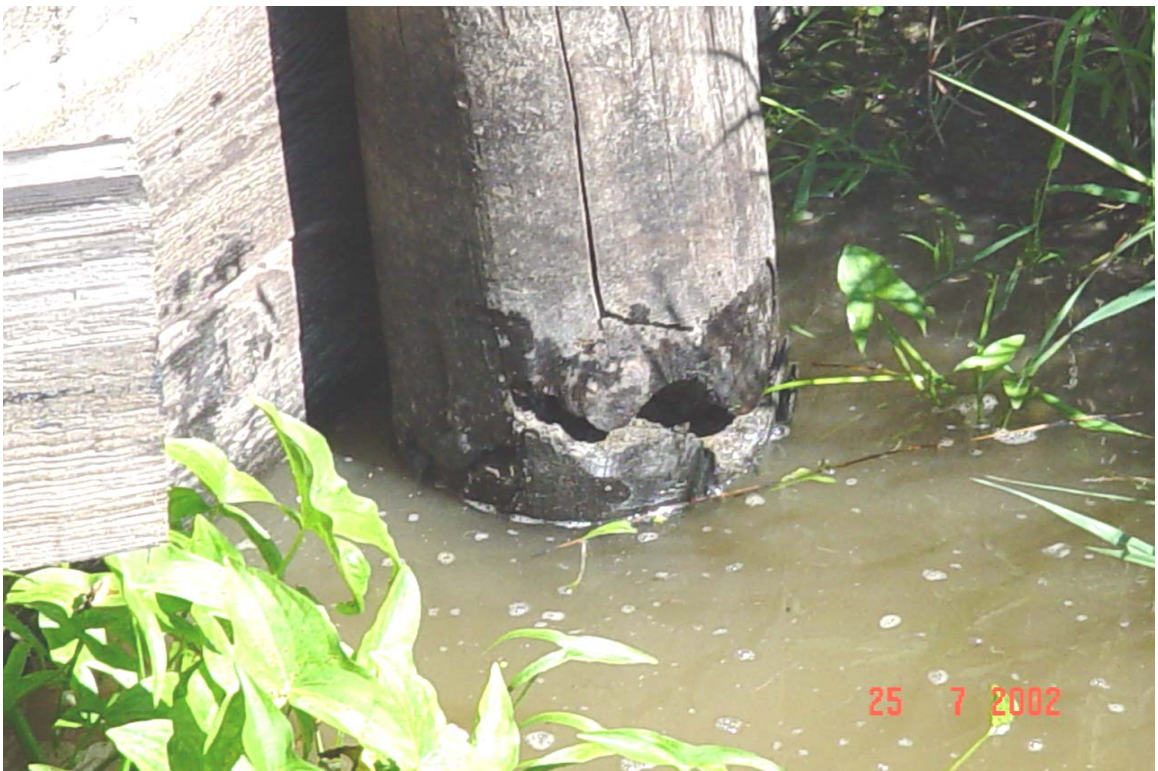
Photograph 4. View of the Pile Section Loss at the East Wingwall of the North Abutment, Looking North.

REMARKS: Overall, the timber piles and timber planking of the abutment backwalls and wingwalls were in good to satisfactory condition with random checking or cracking up to 1/8 inch wide. One timber pile on the northeast wingwall exhibited an area of section loss, with decay, separating the pile halfway through at the waterline. One pile at the North Abutment exhibited a 1/2 inch split near the top of the pile, and a 2 inch wide by 3 feet long gap with 6 inch of penetration was present in the North Abutment backwall with a slight amount of fill beginning to escape. Also, near the center of the North Abutment, the bottom of the wall planking was exposed with undermining 2 feet below the waterline with 6 inches of penetration into the gravel backfill behind the abutment.

Monitor the pile with the section loss at the North East Abutment, if further decay/deterioration continues, replacement may be warranted.

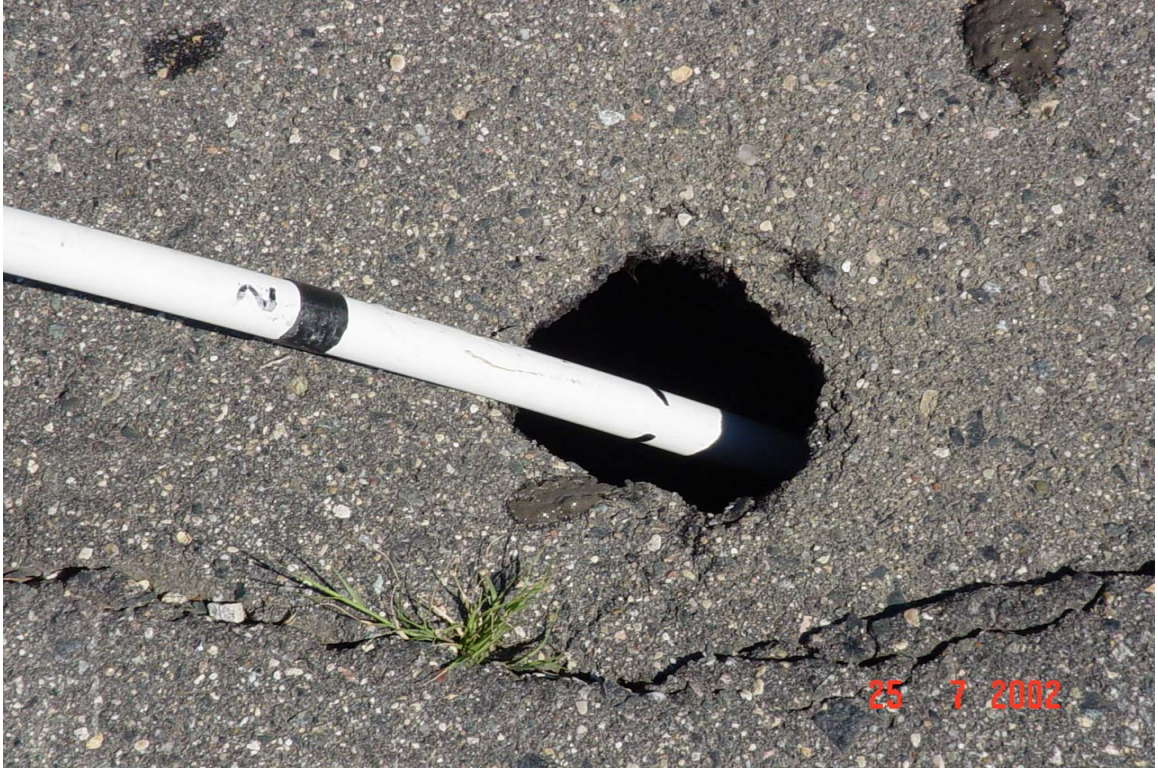
- (A) There was a 1/2 inch wide split near the top of the pile on the east side of the North Abutment. There was also a 2 inch wide by 3 foot long gap observed in the North Abutment backwall planking with evidence of the early stages of fill escaping. There was also a gap at the base of the North Abutment backwall with 6 inches of penetration back behind the wall.
- (B) The corner timber pile on the East Wingwall of the North Abutment had a horizontal area of section loss across the pile width at the waterline.
- (C) Although beyond the scope of the underwater inspection, a hole with an underlying cavity was found in the roadway pavement just behind the North Abutment. County Officials were immediately notified.

Photograph 5. View of hole in Pavement behind the North Abutment, Looking North.
